AutoSock Wear Resistance on snowy Roads

2012-01-12

A Saab 95 2.0T has been 4 wheel equipped with 205/55 R16 tires and 4 AutoSocks of model 645.

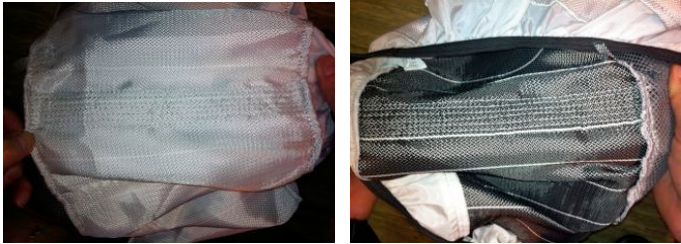
645
 Virgin
 Seams

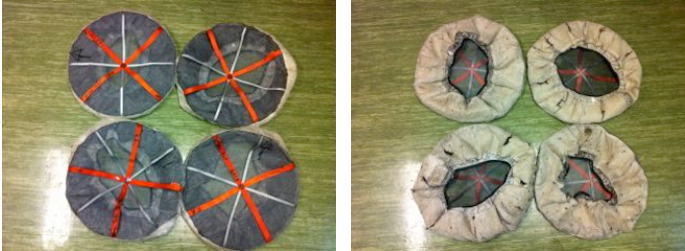
645
 4 Socks
 after
 400km

- No correction/re-adjustment of any AutoSock over the complete 400 km necessary.
- All 4 AutoSocks after 400 km still in good shape & safe on tire.
- Some small cuts/holes, but still no black layer from the RCF white/black double layer visible.
- Assuming, that all 4 socks can last another 200-400km under comparable conditions.

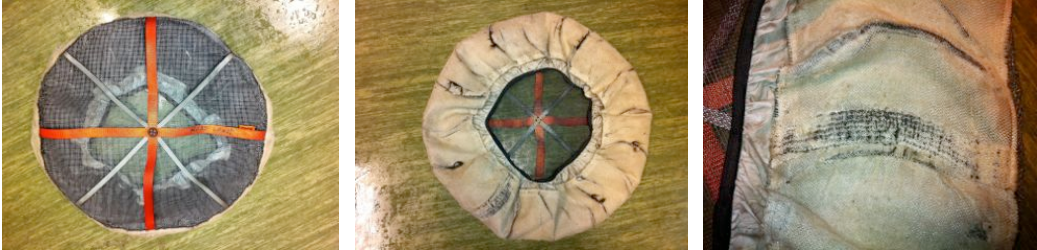
645
 Front
 Left
 after
 400km

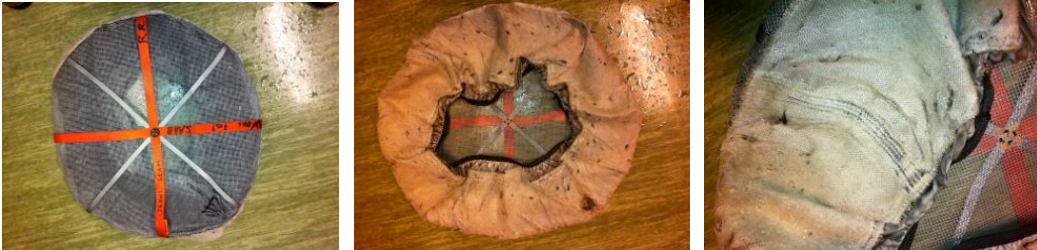
645
 Rear
 Right
 after
 400km

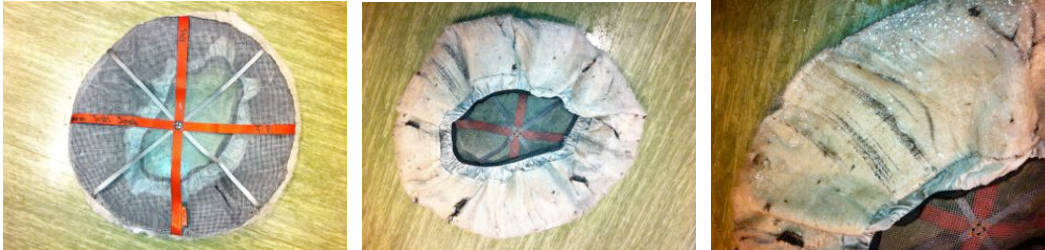
645
 Front
 Right
 after
 400km
